DEPARTMENT OF PLANNING AND NATURAL RESOURCES

EXECUTIVE SUMMARY OPERATION BREATHE EASY II

ST. CROIX CENTRAL HIGH SCHOOL ODOR INVESTIGATION (March 23-April 4, 2014)

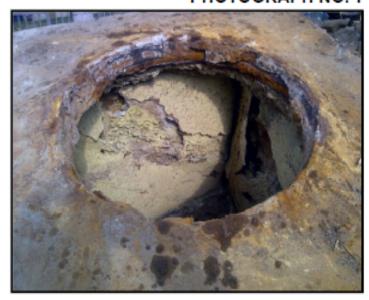
Sulfide Corrosion
Damage to Cover
Ring and Interior
Concrete Surface of
Manhole Between
Curriculum Center
and Territorial Court

- 1) pretreatment of the wastewater at the lift station to reduce H₂S formation;
- 2) cleaning of the inside of the force main and any other activities necessary to increase flow rate and reduce residence time in the force main;
- 3) addition of an air relief valve on the lift station discharge pipe to prevent air binding;

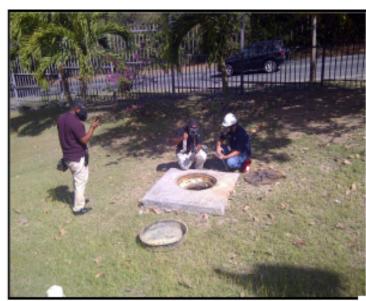
PHOTOGRAPH NO. 2

At the VI Superior Court manhole just downstream of the Transition manhole, levels greater than 600 ppm were detected by the National Guards' CST using their instrumentation. EPA also observed strong odors and detected elevated H_2S levels (> 50 ppb) inside portions of the court building during the investigation. The presence of such a significant continuously produced source of H_2S less than 1000 feet from the school and in close proximity to the Territorial Court and Herbert Grigg makes the sewer a likely potential source of the March 18th release and of subsequent complaints in the Kingshill area.

Sampling Atmosphere in Manhole on Territorial Court Grounds

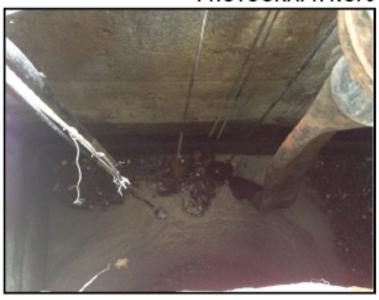
View of Barren Spot Lift Station Wet Well from Above. Pump Discharge Hose is at the Right of the photo; Level Control Floats are at Left

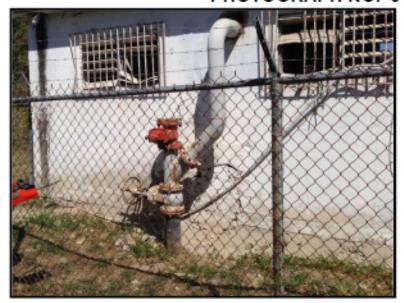
Barren Spot Lift Station Exterior Piping

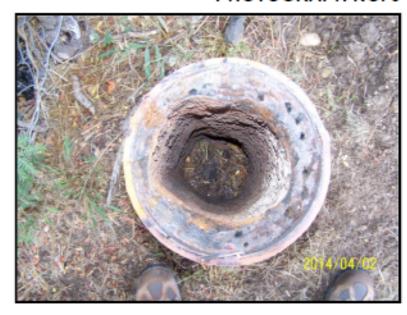
PHOTOGRAPH NO. 6

Section of 8" Force Main Showing Extent of Deposits Inside the

Pipe

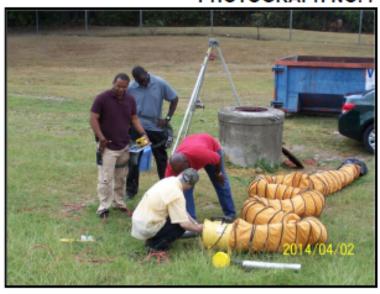
The specific conditions which caused the H_2S gas to migrate to the school are not completely understood, however; the gravity feed line from the school provides a potential pathway to the campus. Additionally, smoke testing revealed multiple venting points throughout the courtyard and classroom area where students and teachers were impacted. Results of interviews conducted during the investigation suggest that there has periodically been a sewer odor at the school indicating that sewer gas has made its way onto campus in the past.

Setting Up Smoke Testing at CHS MH 5

- 4) thorough testing of the CHS sanitary system and repair of all defects that could allow sewer gas to escape; and
- 5) Construction of a "weir structure" in the northwestern most man-hole on the CHS campus to prevent potential migration of sewer gas into the CHS system.
- 6) Department of Education and Public Works should conduct joint inspections of the sewage system at CHS and complete "As Built" Survey of the system.
- 7) the separation of the CHS gravity feed line from the force main transition manhole by moving the transition manhole west of the VI Superior Court
- 8) Eventual decommissioning of the Barren Spot lift station as a long term plan is also deemed appropriate.

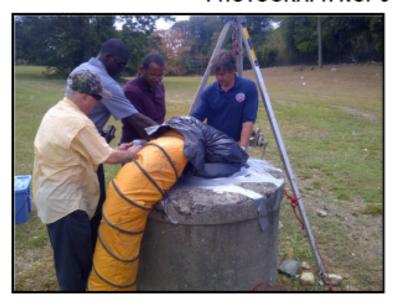
PHOTOGRAPH NO. 8

Attaching Smoke Generator Output Duct to CHS MH 5

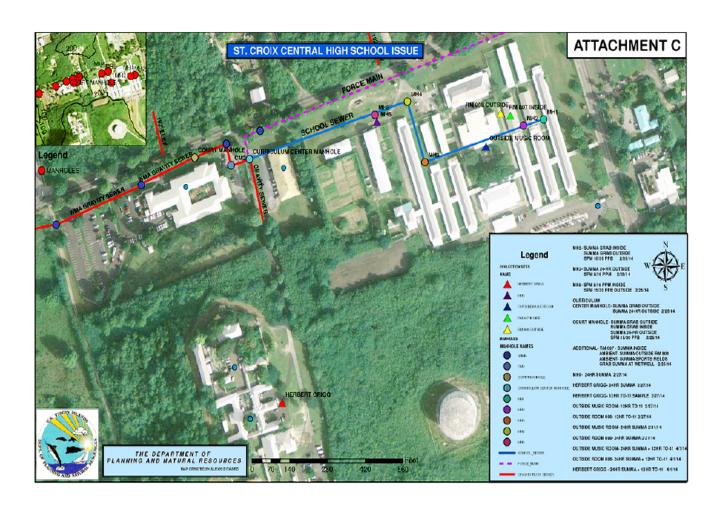
ATTACHMENT C SEWERS AND FORCE MAIN AT ST. CROIX CENTRAL HIGH SCHOOL, CURRICULUM CENTER AND COURT HOUSE COMPLEX

Center or "Transition" manhole is where the force main from the Barren Spot lift station discharges sewage prior to it flowing down the gravity sewer line that runs past the Court and towards the treatment plant located near the airport. This manhole also receives waste from 3 other gravity feed lines, including one from CHS. Levels of hydrogen sulfide measured in the Transition manhole were observed to exceed 200 ppm. This concentration represents the maximum detectable level for EPA's Multi Rae Pro direct-read instrumentation and is twice the Immediately Dangerous to Life and Health (IDLH) threshold published by the National Institute for Occupational Safety and Health.
